# **SITE CHARACTERIZATION SUMMARY REPORT ADDENDUM**

Riverside Industrial Park  
Superfund Site, Newark, Essex  
County, New Jersey

0013620.22  
**PPG, Inc.**  
October 2018

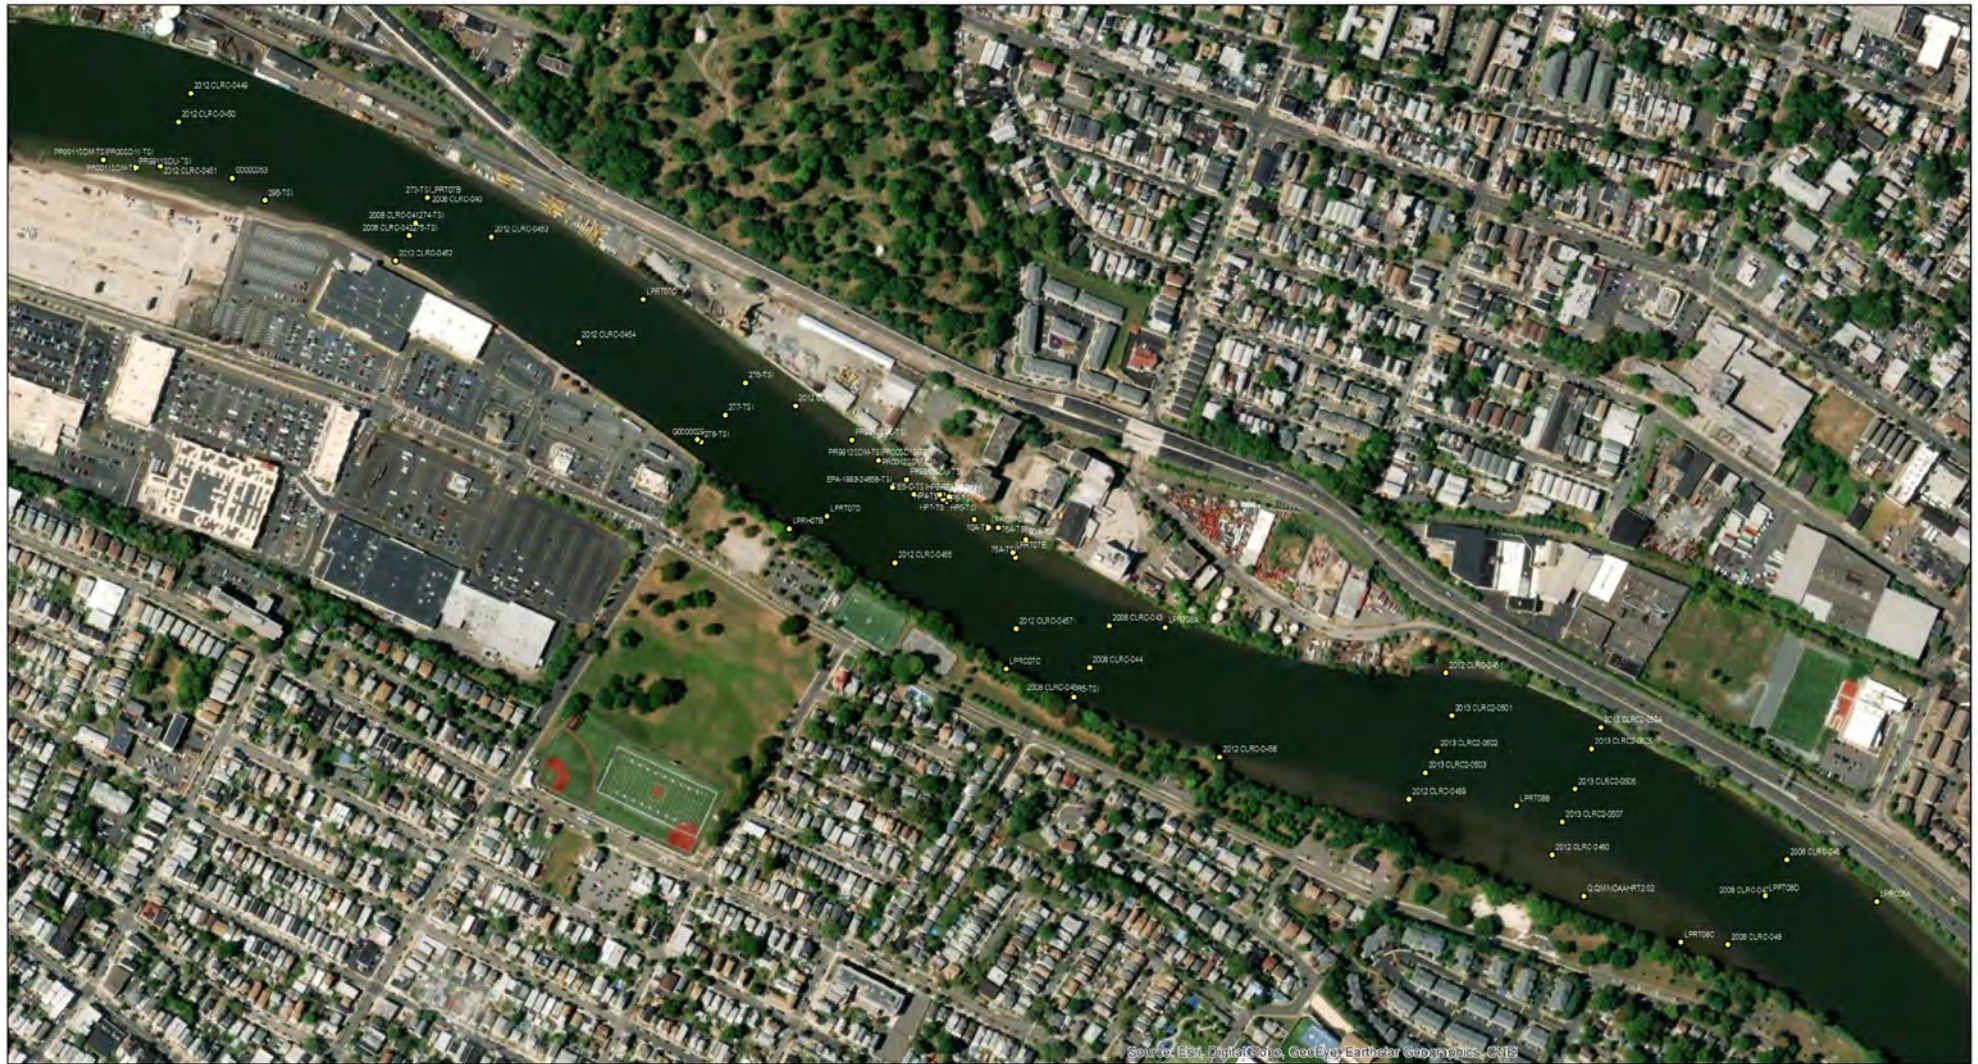
**Figure 9-1**  
**Lower Passaic River**  
**Sediment Sample Locations**  
**Mile Point 6.30 to 7.55**

○ Approximate Sediment Sample Locations
